WEST LEECHBURG RESERVOIR DAM

**PHASE I INSPECTION REPORT
NATIONAL DAM INSPECTION PROGRAM**

GAI CONSULTANTS, INC.
570 BEATTY ROAD
MONROEVILLE, PENNSYLVANIA 15146
OCTOBER 1978

PHASE I INSPECTION REPORT
NATIONAL DAM INSPECTION PROGRAM
WEST LEECHBURG RESERVOIR DAM
NDI# PA-452, PENNDA# 65-108

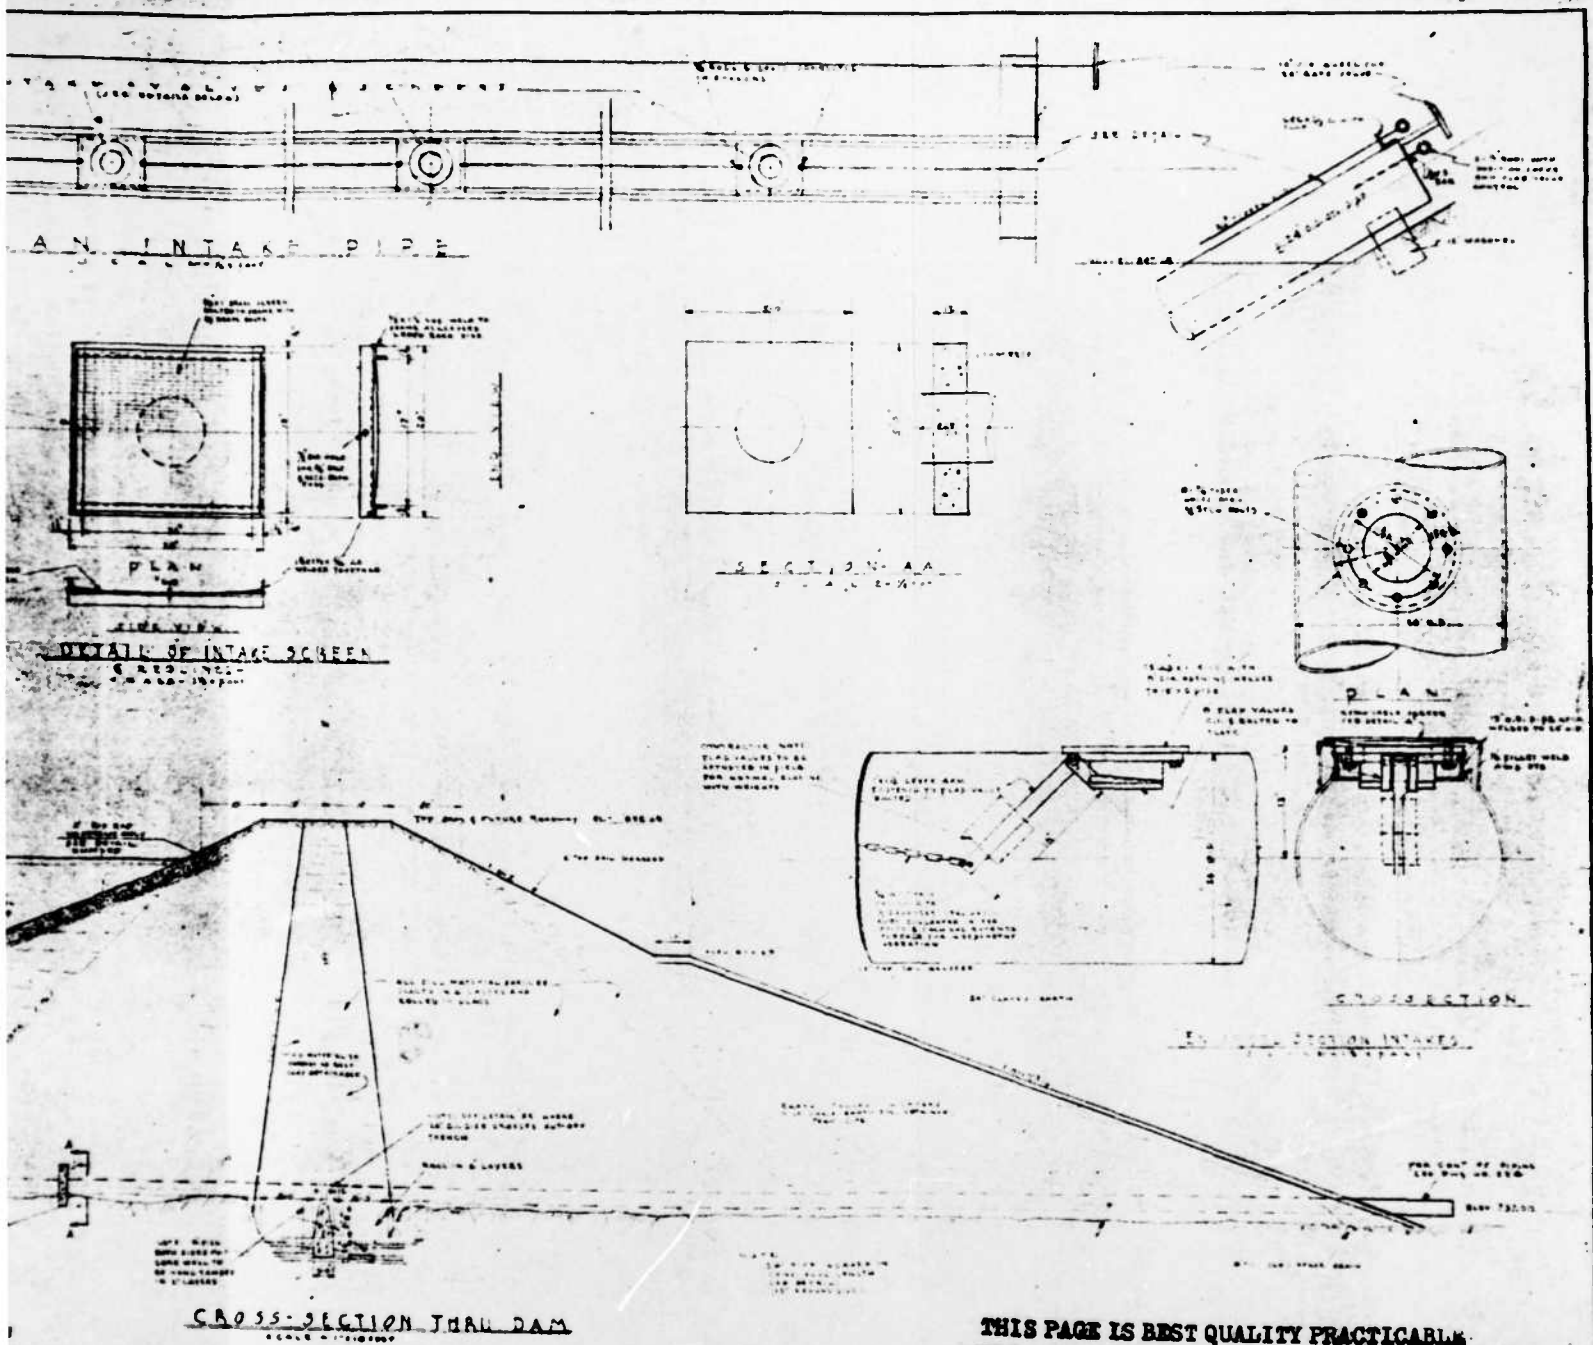
FIGURE 4

Zoning - The interior part of the dam was reportedly constructed of select clay rolled in six-inch layers (see Figure 4). The upstream face was provided with three feet of riprap covering a six-inch layer of crushed stone or gravel.

Closure - Gate valve at tee on inlet end. Five sluice gate type openings along the riser pipe at heights of 5, 15, 25, 35, and 43 feet above the centerline of the outlet pipe (see Figure 4). The outlet pipe is also gated at its outlet end. All of the sluice gates in the riser pipe are reported to be currently inoperable.

inlet end of the system (as shown on Figure 4) was provided with a tee. The straight section of the tee is valved whereas the section at right angles was provided with a 24-inch steel riser pipe that rested on the left abutment and protruded from the water at a point above 175 feet upstream of the dam centerline. The riser pipe was equipped with five openings, thus allowing the water authority to decant water from several elevations within the reservoir. The gate controls for these openings are presently open and are no longer functioning. Thus, flow through the 24-inch outlet pipe cannot be controlled at the inlet end.

The outlet works at the facility consist of a tee connection on a 24-inch cast iron pipe, encased in concrete beneath the embankment (see Figure 4). The straight section of the tee is gated at the inlet end and rests on the bottom of the reservoir acting as a blow-off. The 90°-section of the tee is connected to a riser pipe containing five gated portal openings at different elevations within the reservoir. This riser pipe protrudes from the reservoir upstream of the spillway along the left bank of the reservoir (see Photographs 1, 4, and 8). Controls for both the gate valve on the blow-off pipe and slide gates on the riser pipe, were operated from this point. According to water company personnel, none of these controls are now functional and all riser gates are thought to be open.
